BUILDING ENGINEERING REPORT

Building Name: Federal Building - 517 Gold Avenue SW
Building No.: NM0024ZZ
Location: Albuquerque, New Mexico

Title: Provide New Equipment to Facilitate Handicapped Accessibility

Title: Modify Restroom Vestibules - 9 Men's Restrooms

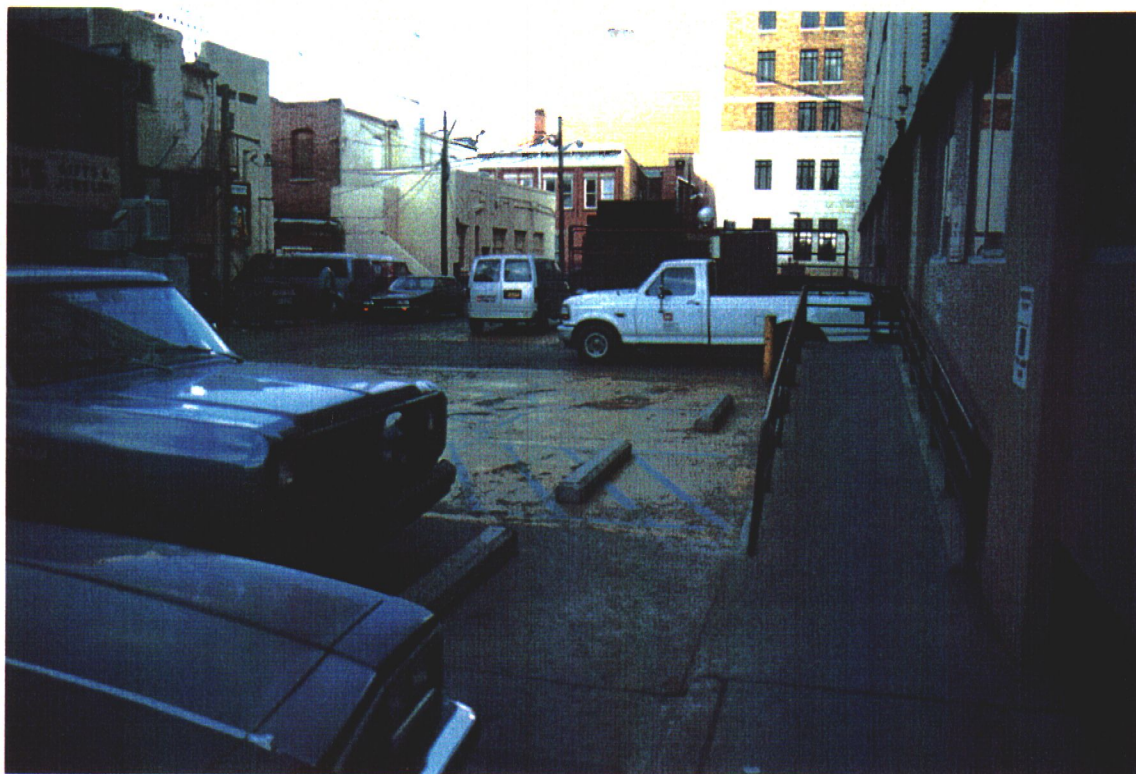
Number: 616.1 - Handicapped Accessibility

Existing Handicap Ramp and North Entry

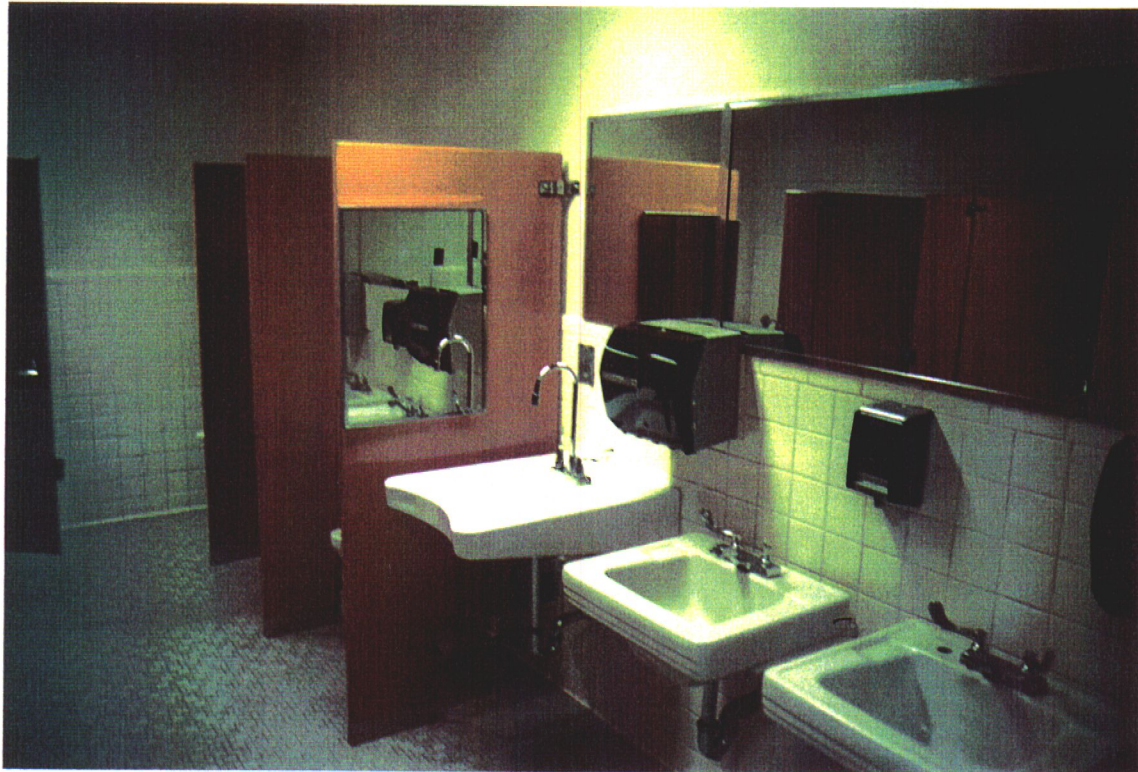
Number: 616.2 Handicapped Accessibility
Title: Restroom Accessibility - 9 Men's Restrooms

The existing restrooms provide handicapped accessible toilet stall with grab bars and a wall mounted sink. The space in the restroom is adequate for a 5' diameter wheelchair turning circle but the vestibule door clearances are unacceptable at the men's restrooms. Accessibility standards require a 48" clearance between a door swing and the next vestibule wall, and 18" clearance from the door jamb (at pull) and the nearby perpendicular wall. The existing men's rooms vestibules must be enlarged to comply. Modification of the janitor's closet next to the vestibule of and deletion of one toilet stall will allow for an increased vestibule. The women's restroom vestibules are sized much larger than mens' because the womens' vestibule is a lounge area. This work is for adequate space clearance at the mens' restroom.

Typical Men's Restroom

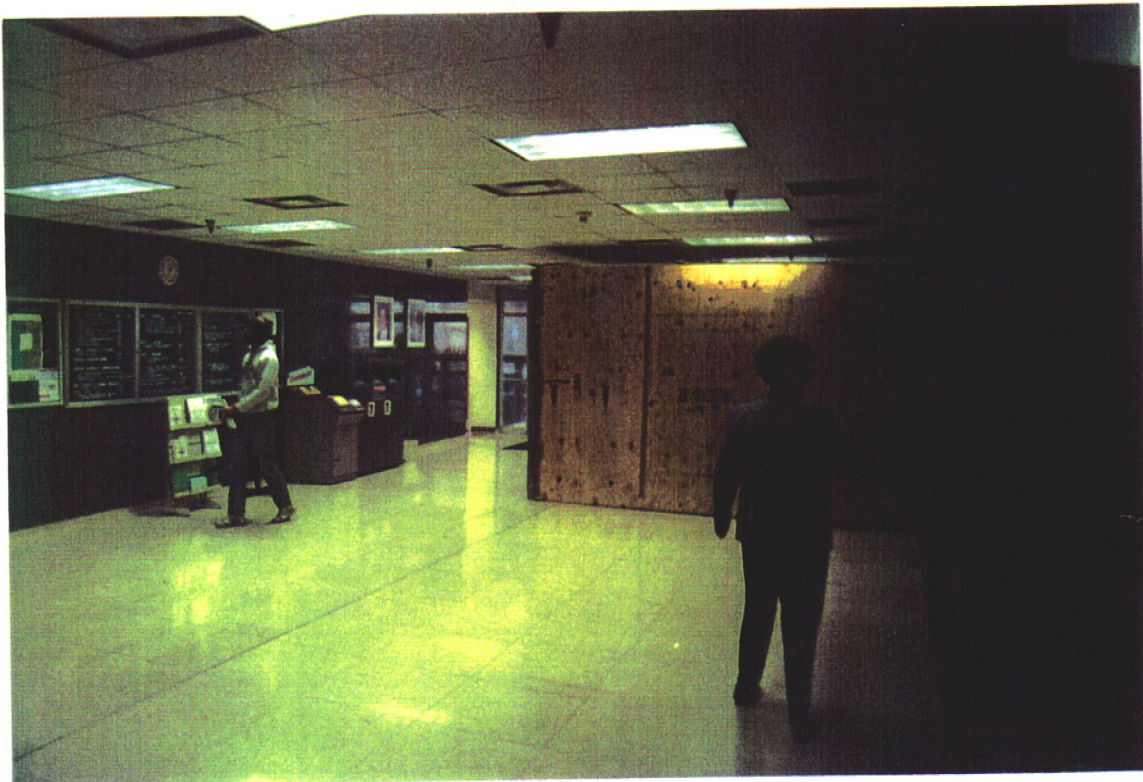
Number: 830.1 - Art in Architecture

There is no art work in this building. Provide sculpture, sculptural relief, paintings, murals and additional art work for the first floor entry lobby and all the elevator lobbies on the above floors.

The art is to enhance the elevator lobbies plain appearance.

Lobby Photos
